NASA TECHNICAL MEMORANDUM

NASA TM -78178

SAMPLE STREAM DISTORTION MODELED IN CONTINUOUS-FLOW ELECTROPHORESIS

By P. H. Rhodes Space Sciences Laboratory

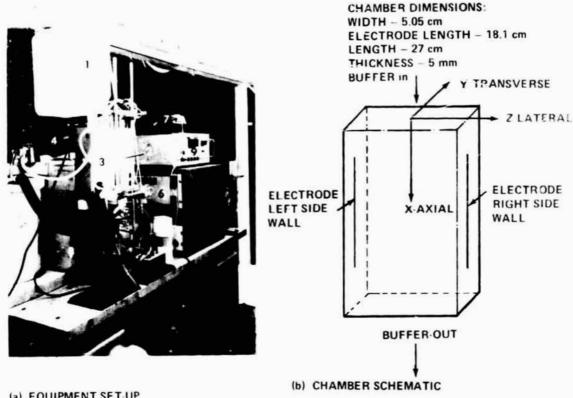
(a) EQUIPMENT SET-UP

- 1. BUFFER RESERVOIR
- 2. FLOW CHAMBER
- 3. BACK LIGHT
- 4. SYRINGE PUMP
- 5. COOLER RESERVOIR
- **6 TEMPERATURE RECORDER**
- 7. VOLTMETER
- 8. POWER SUPPLY
- 9. WATTMETER

Figure 1. Apparatus used in phase I experiments.

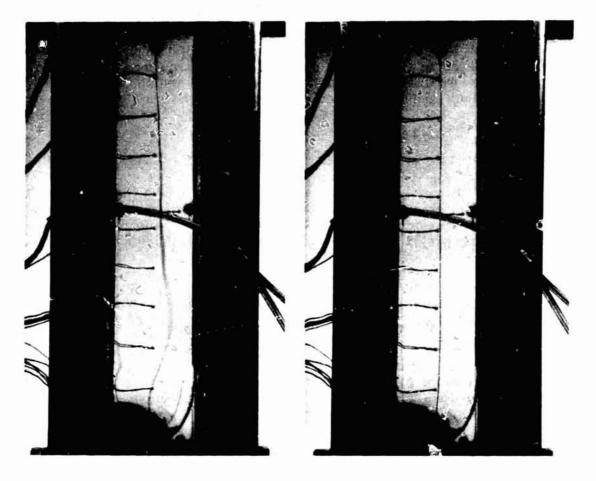
Figure 5. Typical stream distortion.

Figure 6. Typical stream ribbon formation.

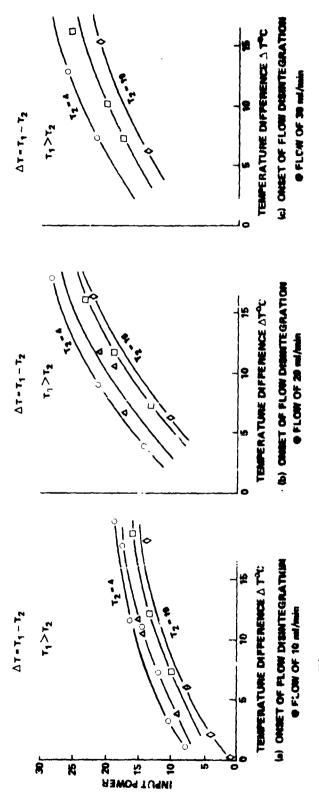
Figure 7 shows the limit of stability in the flow chamber for three buffer flow rates. Note that stability is enhanced by (a) increasing flow rate. (b) increasing axial temperature difference AT, and (c) decreasing chamber temperature by decreasing the coolant temperature T₂. Increasing the buffer flow rate effectively swamps out buoyancy-driven disturbances, thus contributing to flow stability; increasing the axial temperature difference AT reduces the probability for the occurrence of

Figure 7. Lamits of power input at the onset of unstable flow.

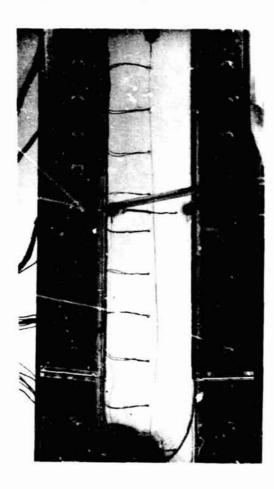
The effect of lateral temperature gradients is very important, as the following sequence of test results indicates. Figure 8 shows a steady flow situation with side wall cooling on both sides. Note the flow disturbance at the termination of the left electrode, which is due to insufficient cooling of the left side wall. The perturbation appears centered at the electrode termination. The main stream is deflected to the right because the flow is necessarily deflected away from the region of retarded flow on the left. Figure 9 shows the development of a disturbance pattern on the right side 3 min after side wall coolant flow was stopped on that side. The disturbance initially developed at the termination of the electrode and moved up a shown. Note deflection of the main stream to the left as a result of the induced flow obstruction. Figure 10 shows the development of a circulation pattern at the location of the

Figure 8. Flow with cooling both sides (arrow marks electrode termination).

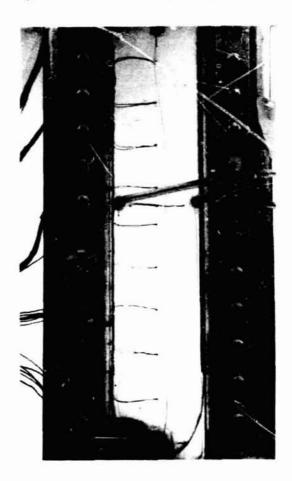
Figure 9. Flow with cooling left side only.

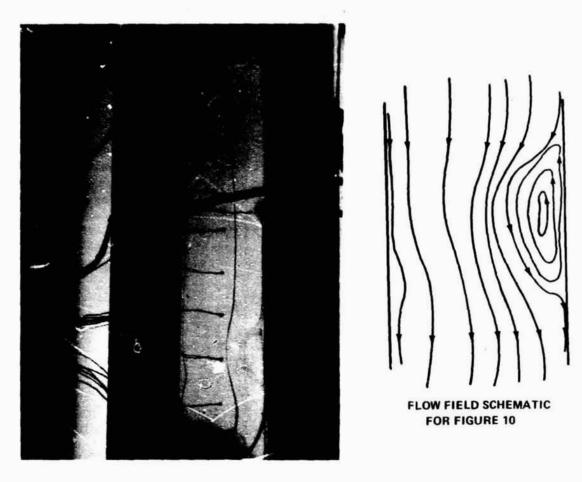
Figure 10. Flow with cooling left side only.

previously observed disturbance with the accompanying further deflection of the main stream. Figure 11 shows reestablishment of the initial flow situation 2 min after resumption of coolant flow in the right side wall. Figure 12 shows the flow configuration 6 min after elamping flow on the left side wall. Here again, the flow disturbance has developed into a circulation pattern which has caused the appropriate main stream deflection.

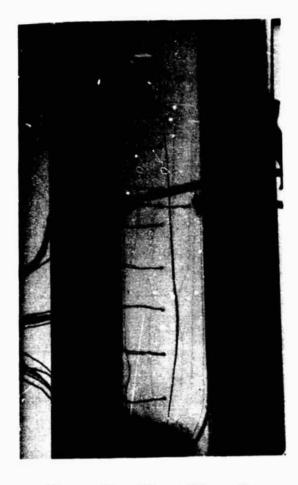
Figure 11. Flow with cooling both sides.

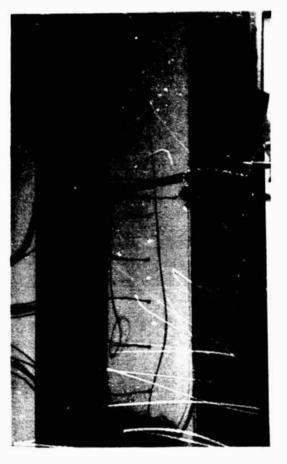
The previously mentioned ribbon formation is thought to be caused by the transverse temperature gradient producing upward directed buoyancy flows which blunt the parabolic velocity profile of the buffer flow through the chamber. The following experiment suggests that secondary flows in the chamber cross section cause the observed ribbon twists and deformation. Figure 13 shows an initially straight ribbon with a leak provided in the right sample inlet port. This leak should cause deflection of the stream by inducing a lateral flow in the chamber

Figure 12. Flow with cooling right side only.

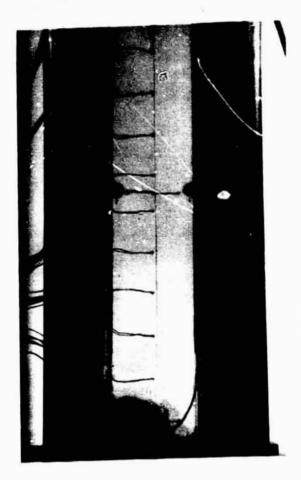
Figure 13. Flow at initiation of leak.

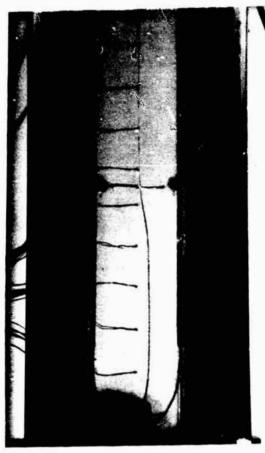
cross section. Figure 14 shows the stream configuration 2 min after initiation of the leak. Note the deflection and twist of the ribbon which is apparently due to the induced cross flow in the chamber. Figure 15 shows the original straight ribbon reformed 4 min after plugging the leak.

Figure 14. Flow with leak on right side.

That the previously discussed velocity redistribution in the chamber does produce the observed deflection has been shown experimentally in Figure 14. Here the velocity profile was modified by inducing a fluid leak which produces the same type of velocity field as shown in Figure 22 and as depicted by equation (5).

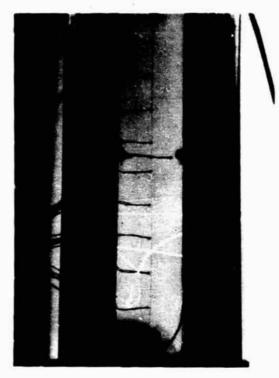
Figure 15. Flow without leak.

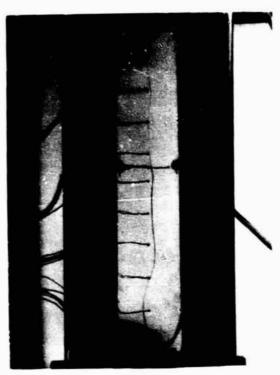
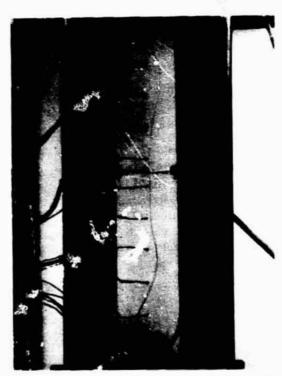
As the power input to the system is increased, the circulations are enlarged so that they cover nearly the entire flow region (as Figures 16 and 17 indicate), subsequently destroying the stable axial temperature

Figure 16. Flow at power input 4.3 W, t = 0.

Figure 17. Flow at power input 4.3 W, t = 19 min.

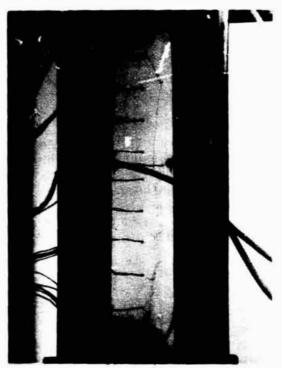
Figure 18. Flow at power input 23.3 W.

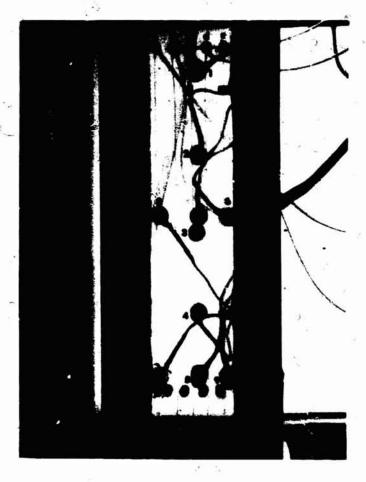
Figure 19. Phase II test chamber with thermistor locations.

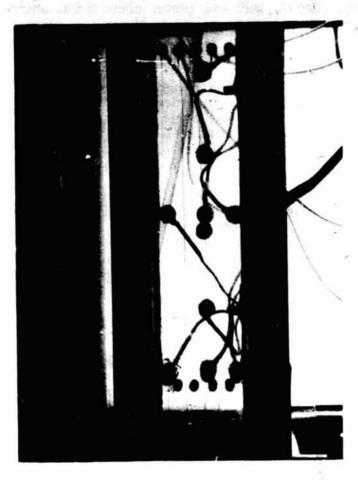
Figure 20. Flow at power input of 4.66 W.

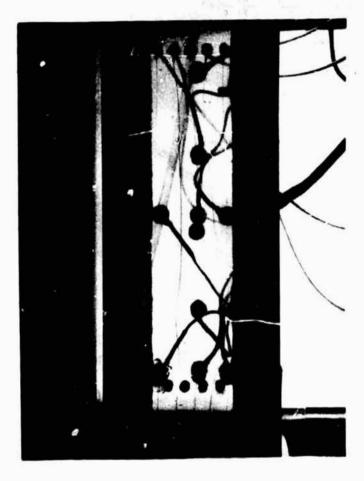
Figure 21 shows the flow configuration at a power input of 6.82 W. The disturbances previously observed have increased in size and ribbons have been formed with twists. The flow, however deformed, is still quite stable.

Table 4 shows the continual degradation of the stable axial gradient at the top of the chamber, i.e., ΔT_{1-2} . The unstable gradient between thermistors 3 and 4 (ΔT_{3-4}) is also increased, which is in agreement with the observed enlarged disturbances.

Figure 21. Flow at power input of 6.82 W.

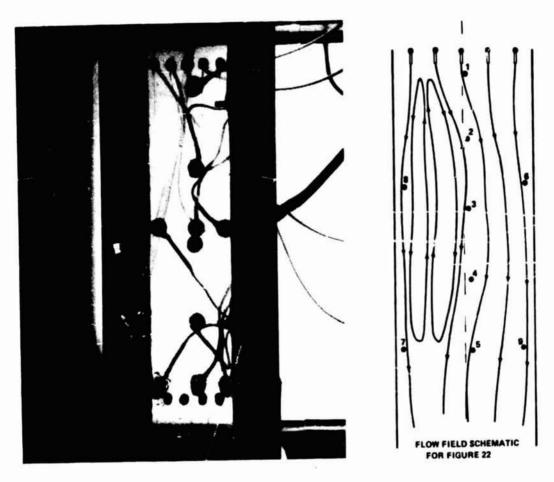
Figure 22 shows the flow at a power input of 8.00 W. Note that the disturbances on the left side of the chamber have enlarged and together confine flow to the right side of the chamber cross section. Observe that stream b is breaking up in the region between thermistors 4 and 7 and clearly shows a circulation pattern beginning to develop.

Table 5 shows the temperatures present at the termination of the run. Note the negative gradients in the vicinity of the observed circulation patterns and the general approach to zero for gradients at the

Figure 32. Flow at power input of 8.00 W.

Several of the test runs have Rayleigh numbers near the preceding value. Consider the results of Table 5 and the flow shown in Figure 22. There appears to be a retardation of flow on the left side of the chamber — a condition characteristic of the antisymmetric mode of equation (5).

It is very interesting to note that the velocity distribution at thermistor 4 in Figure 22 shows this exact velocity distribution. In particular, note the downflow at the left side wall, the diffused conditions of streams b and c at the left center and right center of the chamber, and the region of high downflow on the right. Figure 35 shows the downflow on the extreme left, a region of high shear at the center, and high downflow on the right.

Note also a similar region of flow perturbation at thermistor 2 in Figure 22. This disturbance is caused by the adverse temperature gradient between thermistors 1 and 2. The gradient is not sufficient, however, to cause backflow, but does cause the deflection of stream b due to the retarded flow on the left side of the chamber — in agreement with the conditions predicted by equation (5).

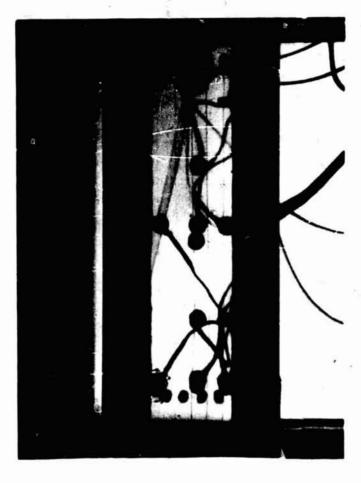
Figure 23. Flow at zero power input.

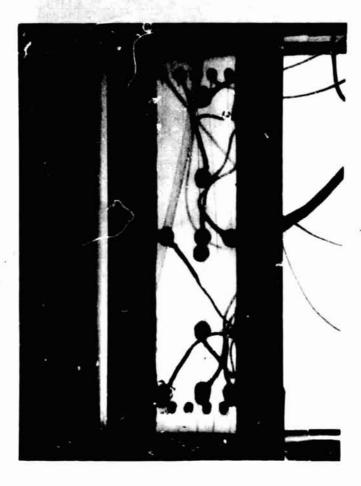
Figure 24 shows the flow configuration at a power input of 7.70 W. Note the deflection of the sample streams to the right, indicating the development of disturbances (flow retardations) on the left side of the chamber. Also observe the ribbon formations; sample stream b exhibits an undeformed ribbon while the ribbon of stream c is twisted. As shown in the phase I leak experiments, this condition implies the existence of secondary flows in the chamber cross section. Table 7 shows the temperatures present in the chamber. Note the large decline in favorable gradient at the top of the chamber when compared to the zero power condition.

Figure 24. Flow at power input of 7.70 W.

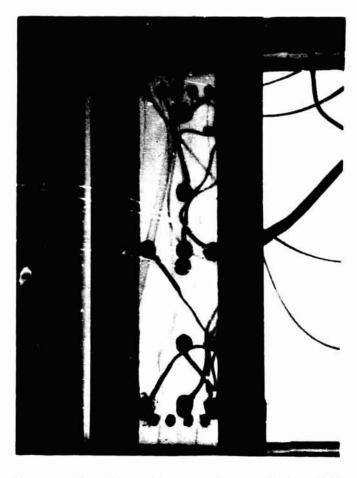
Table 8 shows that adverse axial gradients exist in the vicinity of the observed disturbances.

Figure 25 Flow at power input of 12.00 W.

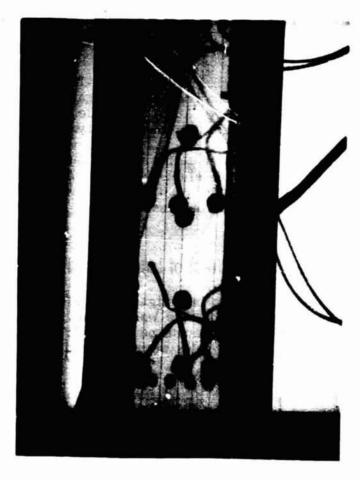
A final run will now be shown in which the disturbance patterns lescribed previously occur in a striking fashion due to a smaller imposed axial gradient. Figure 26 shows the stable zero power flow configuration, while Table 9 shows the associated temperatures.

Note the reduced favorable gradients due to the smaller overall axial gradient. Indeed, a slight adverse lateral gradient exists between thermistors 3 and 8.

Figure 26. Flow at zero power input.

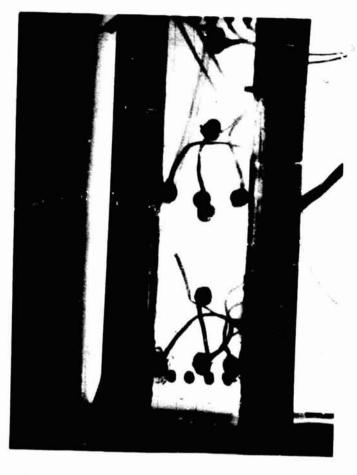
The following series of tests investigated the effect of lateral gradients induced by shutoff of the side wall cooling. First, a uniform flow situation was initiated at a moderate power level; then one side wall flow was shut off, and the results were observed and comparison made with the initial flow condition.

Figure 28. Flow with both side walls cooled. 5.70 W.

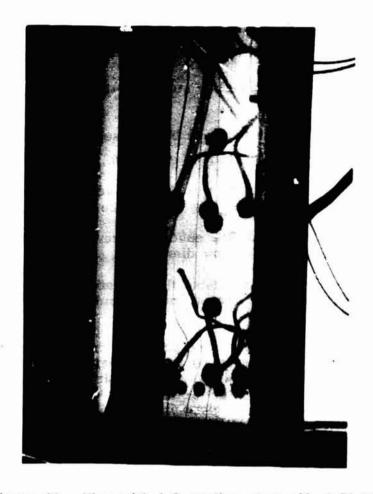
Figure 29 shows two disturbances which developed at the left side wall 3.5 min after coolant to that side was shut off. These are typical of those observed in the phase I tests and appear to initiate at the side wall near the termination of the electrode. Table 12 shows the associated temperatures.

Note the increased adverse lateral gradient between thermistors 3 and 8 and the decrease in stable gradient between 5 and 7, as expected with the left side coolant off. It is obvious that these lateral gradients initiate the observed disturbances; however, it is not clear why they occur at the electrode terminations. The high thermal conductivity of the electrode itself could cause high local lateral gradients at the electrode terminations. When disturbances occur, there must be an interaction between the local axial and lateral gradients due to the convective process. This is seen by comparing Table 11 to Table 12 with respect to the axial and lateral gradients. This relationship is, however, shown much more distinctly in the following case of zero power runs.

Figure 29. Flow with left cooling shut off, 5.70 W.

Flow disturbances produced by adverse lateral gradients (as in Figure 29) produce up flow at the wall. Therefore, it is obvious from the flows observed that localized heating on the side walls is responsible for these disturbances.

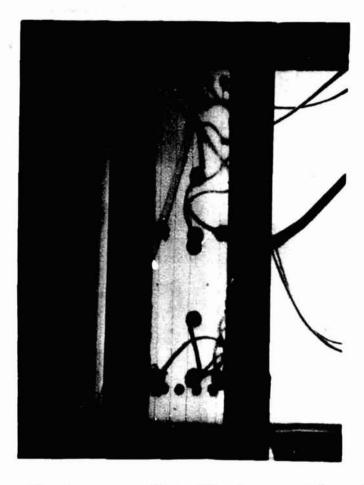
- a) The coolant exit temperature T_3 was set slightly below the buffer inlet temperature T_1 to produce a uniform, stable configuration.
- b) The coolant temperature was then allowed to rise slowly so that an unstable flow condition at zero power would be approached, while
- c) The temperature and flow conditions were monitored to provide information on the mechanism of flow disruption.

Figure 30. Zero power flow with adverse axial gradient.

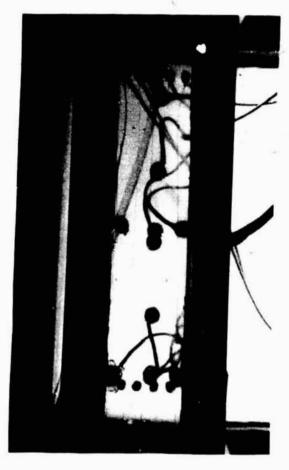
Figure 31 shows two disturbance patterns forming near the top of the chamber with up-flow (separation) being initiated at the upper left (chamber) side wall. Figure 32 shows the flow situation 1 min later with the up-flow moving into the top of the chamber. The temperatures associated with this configuration are given in Table 14. The disturbances appear in the region of the chamber where adverse axial temperature gradients exist, although sizeable adverse lateral gradients are probably there also (not shown due to inadequate thermistor coverage), as indicated by ΔT_{3-6} and ΔT_{3-8} .

Figure 31. Initiation of flow disturbance at zero power.

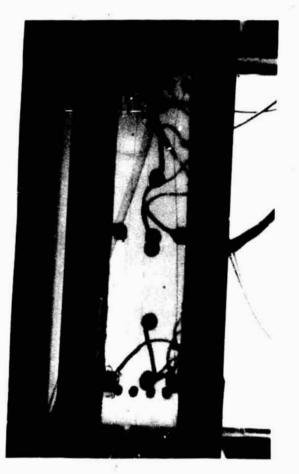
Figure 32. Reverse flow disturbance at zero power.

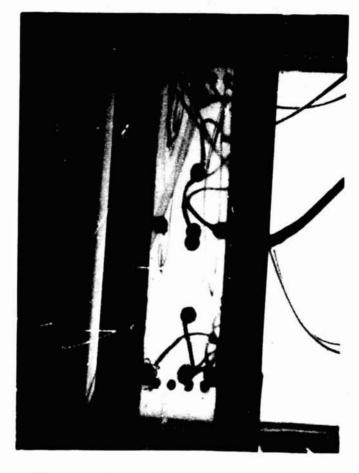
Figure 33 shows well-developed circulations in the chamber with only stream c flowing directly through the chamber. Circulation pairs which rotate in opposite directions are seen to be located on each side of stream c near the middle of the chamber. Table 15 shows the rather large adverse lateral gradients which are probably responsible for these observed circulations.

Figure 33. Development of circulations at zero power.

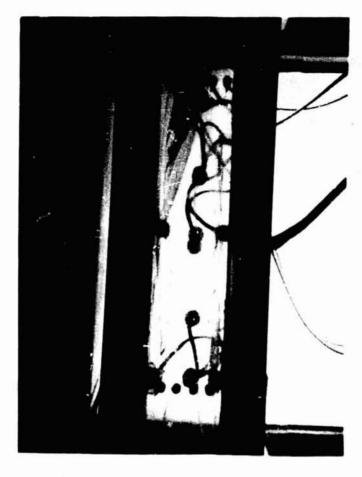
Figure 34 shows a final state of apparently chaotic flow; however, careful observation will reveal two large circulation patterns on each side of the chamber while the streams from ports d and e execute a tortuous route through the chamber. Table 16 shows the temperatures associated with Figure 34. Note the large lateral temperature gradients associated with this flow which are apparently responsible for the two large circulation patterns which extend nearly the length of the chamber. The small adverse axial gradients associated with this flow tend to support this supposition. Further tests, using many more thermistors in the chamber, are needed to determine the exact relation between these types of gradients.

Figure 34. Onset of unstable flow.

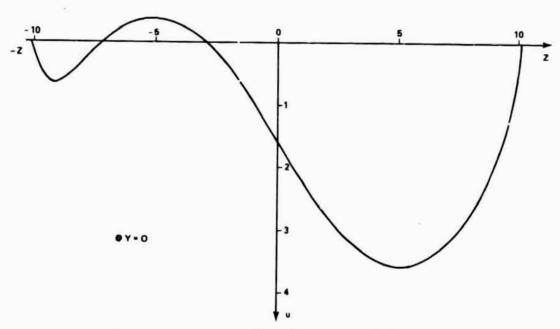
If we assume A(1.02) = 2 and superimpose equation (5) on the symmetric base flow, we obtain the velocity distribution given in Figure 35. Here A(1.02) is an arbitrary amplitude of the antisymmetric mode at x = 1.02, so that relative amplitudes of disturbance flow to base flow are:

$$\frac{A(1.02)}{u(0,0)} = \frac{2.0}{1.6} = 1.25.$$

Figure 35. Superposition of antisymmetrical flow disturbance on the base flow.
